TS-PIC-20202335S
May 2002

AERIAL PHOTOGRAPHIC ANALYSIS OF STANDARD CHLORINE CHEMICAL CORPORATION SITE Kearny, New Jersey

AERIAL PHOTOGRAPHIC ANALYSIS OF
STANDARD CHLORINE CHEMICAL CORPORATION SITE

Kearny, New Jersey

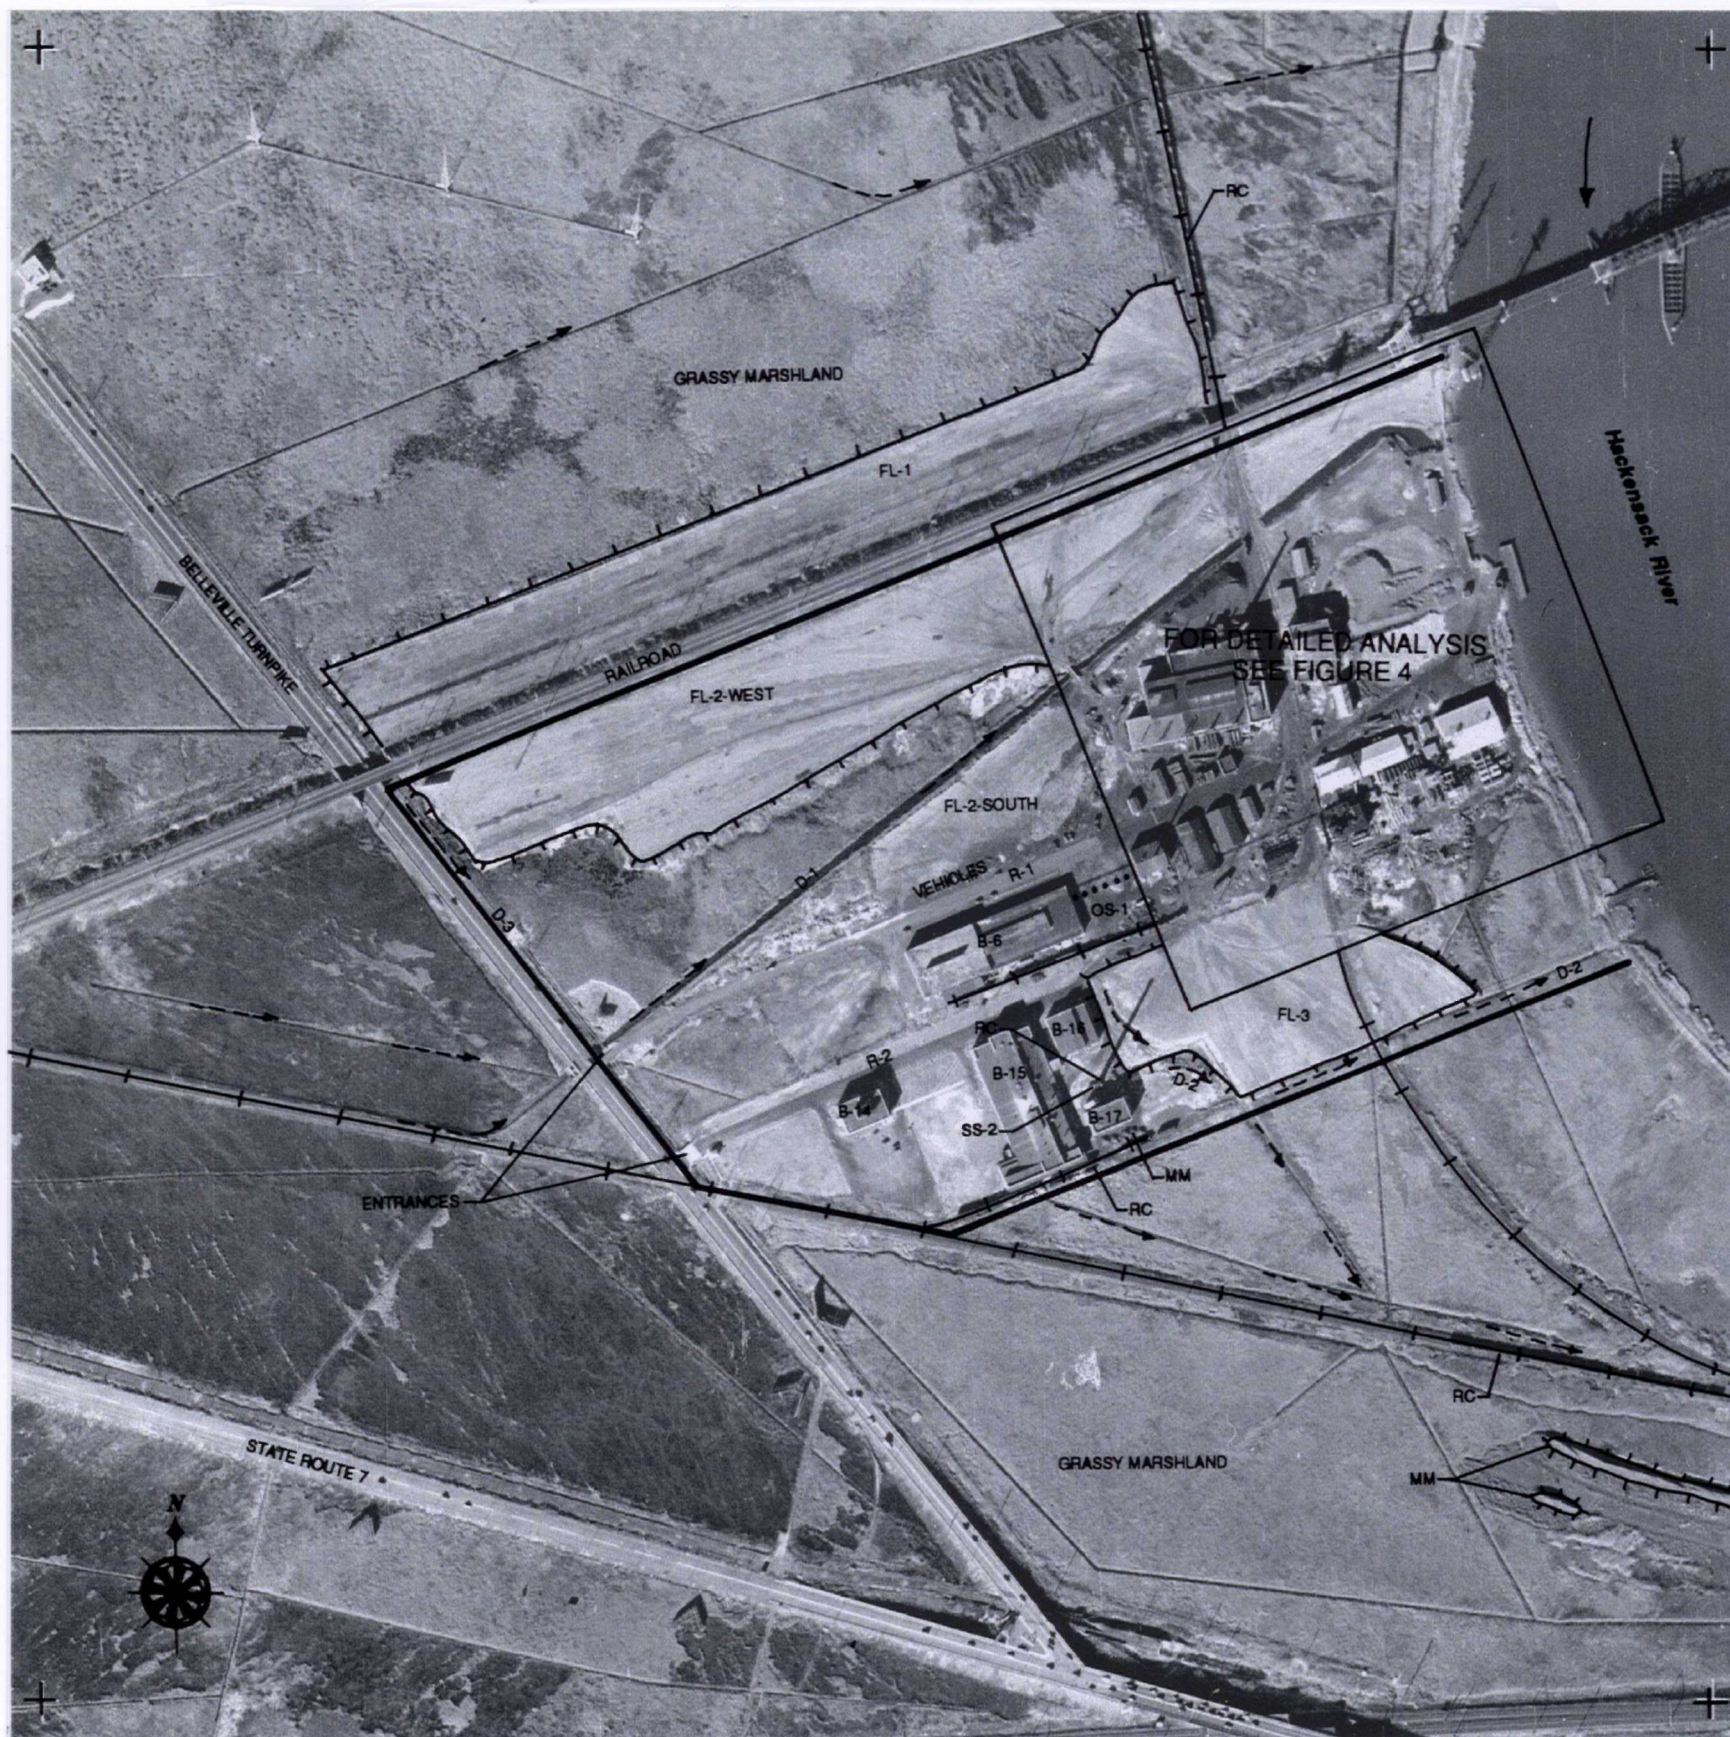
Two elongated mounds (MM) are observed south of the site and appear to be composed of fill associated with probable roadbed construction.

The northern perimeter of the site is denoted by a raised railroad bed. Filling operations have raised and leveled strips of land (FL-2-West and FL-2-East). Dark-toned stains (DT ST) and dark-toned material (DTM) are noted in fill area FL-2-West.

A large building (B-1) is observed on the north side of roadway R1. A dark-toned stockpile (SP-1) is visible on the north side of this building. There are two vertical columns (VC) and a tall smokestack (SS-1) connected to the north side of building B-1. On the south side of this building are a group of approximately six horizontal tanks (HT). The lack of stereoscopic images precludes observing the tanks and columns clearly and any secondary containment structures are not apparent. Smaller buildings (B) and sheds (SH) are also visible adjacent to the large processing building B-1. Patches of light-toned mounded material (LTMM), which could be dry material spillage, are noted on the west and north sides of the building. Additional buildings (B-7 through B-10) are located south of building B-1 and are connected by pipeline to tank farms further to the east. Mounded material is visible south of building B-7.

Four buildings (B-2 through B-5) are located to the east of building B-1, separated by the railroad that enters the site from the north. An elevated pipeline is observed connecting buildings B-1 and B-4. The open area east of building B-4 contains two stockpiles (SP-2 and SP-3). No containment berms or other barriers that would prevent runoff from the chemical plant from flowing east and directly into the adjacent river are discerned along the river bank.

Tank farms containing rows of horizontal and vertical tanks, approximately 25 tanks total, are observed to the south of buildings B-11 and B-12. Building B-13 is also linked by pipeline to building B-7. The lack of stereoscopic analysis precludes observing the tanks clearly and any secondary containment structures can not be discerned. South of the tank farm is an open storage area (OS-2) that exhibits poor housekeeping practices as evidenced by numerous deposits of light-toned material (LTM), dark-toned material, and mixed light-

and dark-toned material. A possible derelict horizontal tank and two possible horizontal tanks are visible further south and east of building B-13. A long deposit of light-toned material is also observed along the east side of building B-12.

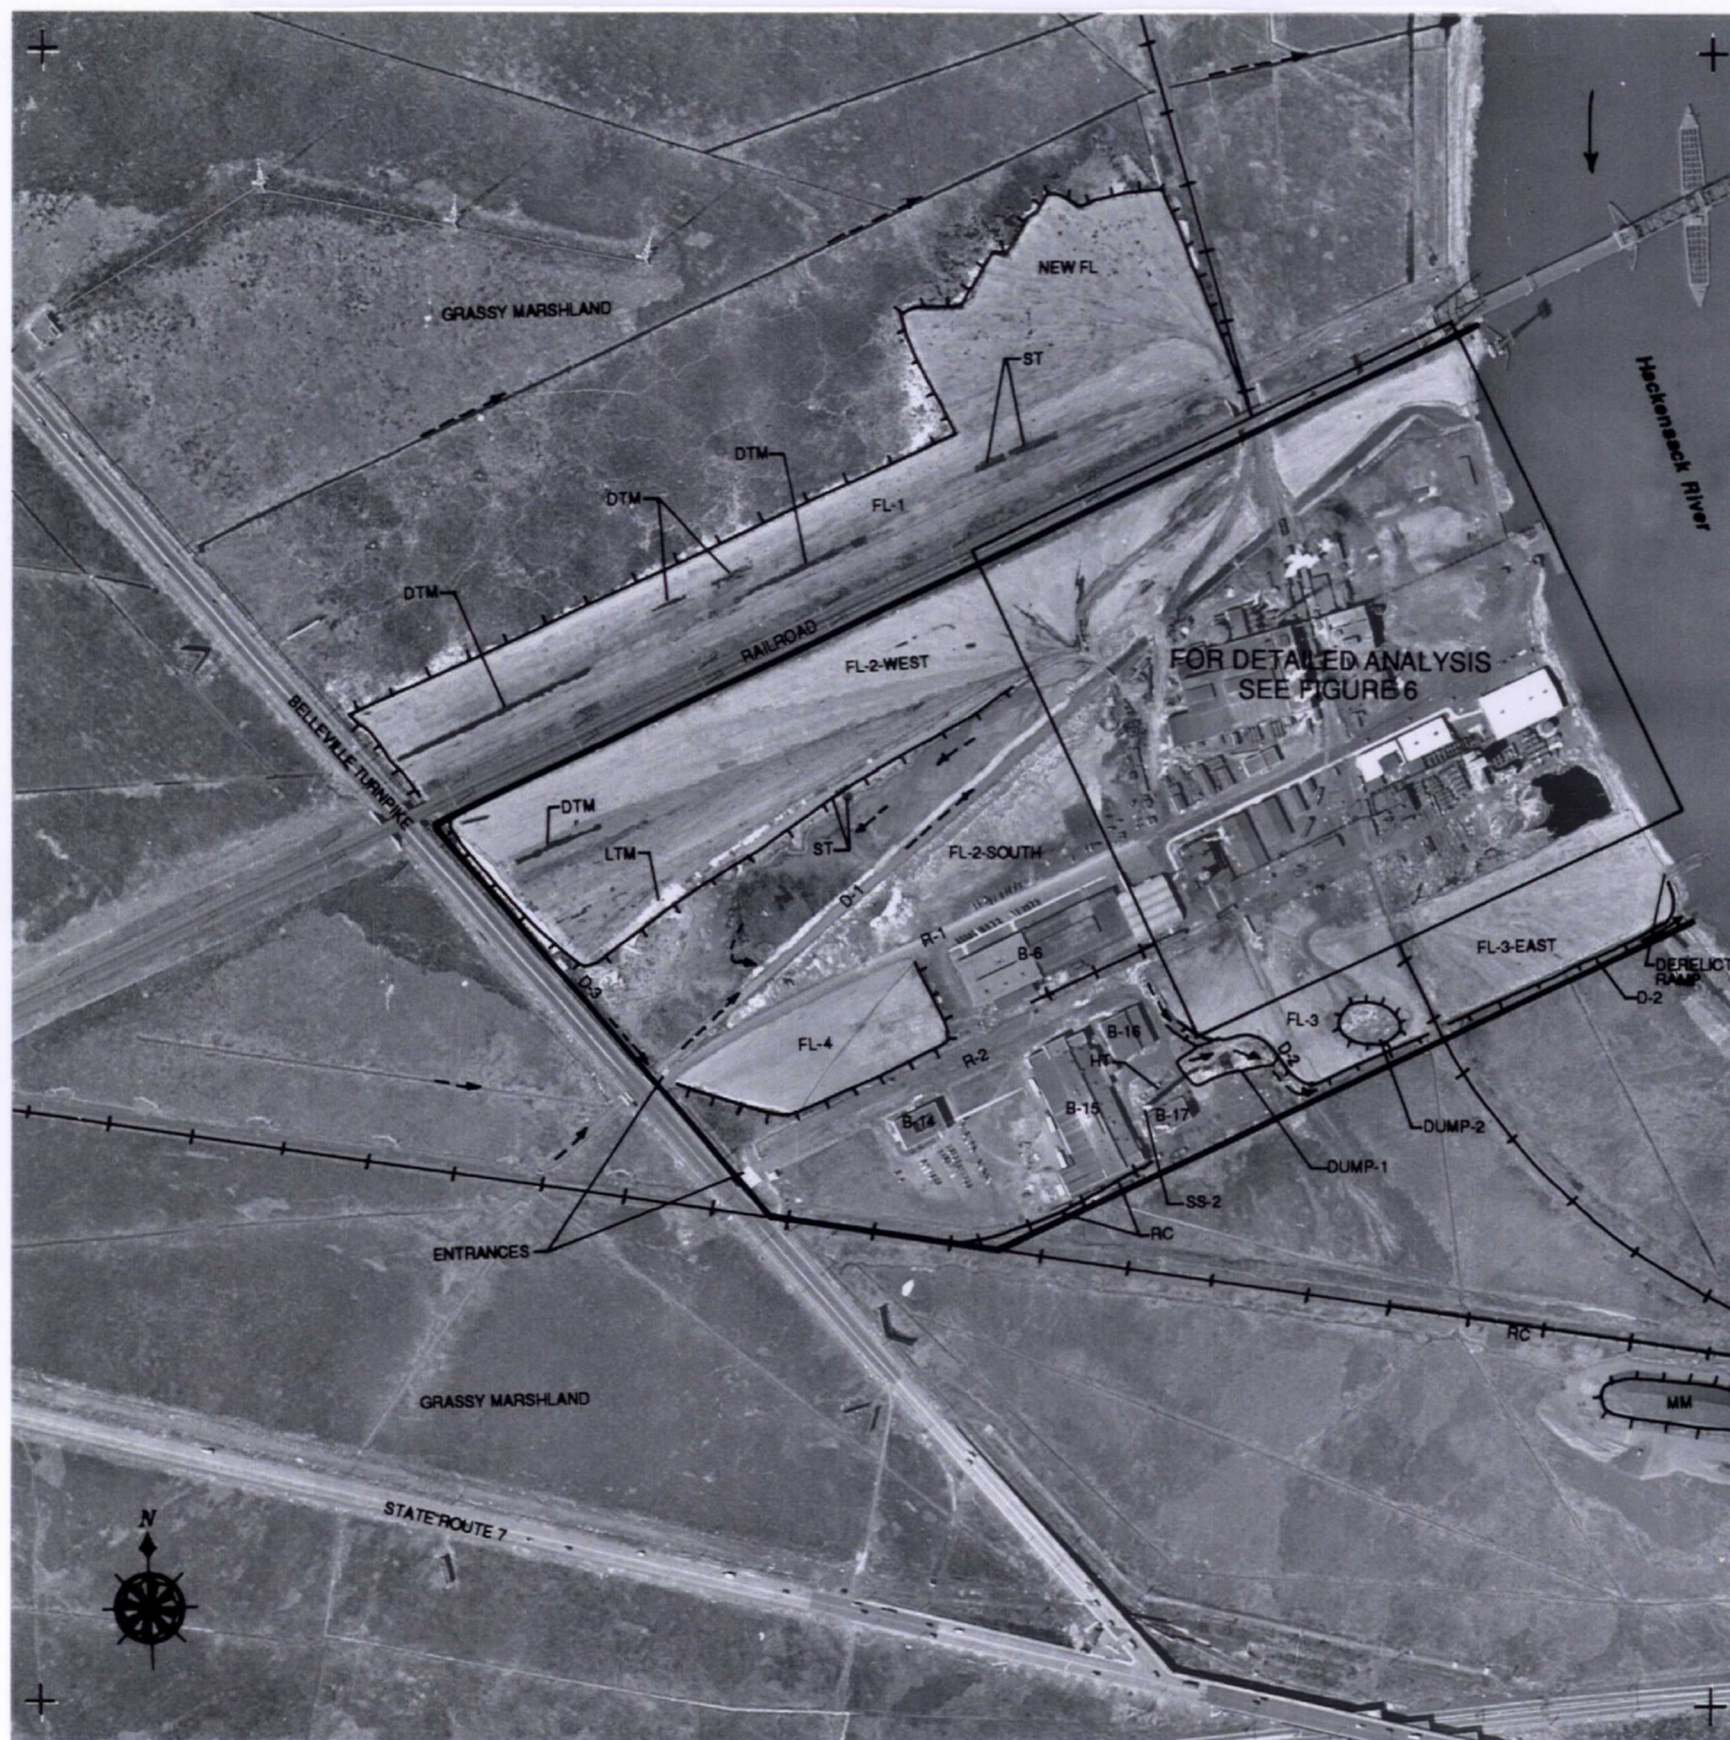
North of the site, filling operations have continued at areas FL-1 and FL-2-West. The northern edge of area FL-1 has been extended to cover additional grassy marshlands. The Hackensack River channel does not appear to have been altered by these filling operations, however. There are deposits of dark-toned material intermixed with the light-toned fill noted in areas FL-1 and FL-2-West; there are also dark-toned stains (ST) from possible liquid dumping and an area of light-toned material on the southern edge of area FL-2-West.

Another fill area (FL-4) where the land has been raised and leveled is observed west of building B-6. Several railroad tankcars (not annotated) are noted along the spur that serves building B-6.

The chemical facility continues to be operational. Although stereo photo coverage was reviewed, a perimeter fence is not discerned. Buildings B-14 through B-17 south of roadway R-2 do not appear to have been modified since 1940; smokestack SS-2 is present but no emissions are discerned. Both railroad cars and cargo trucks (not annotated) are observed at building B-15. One horizontal storage tank is visible on the north side of building B-17. Two open dumps (Dump-1, Dump-2) that contain mixed light- and dark-toned material are visible to the northeast and east of building B-17; these dumps appear to be accessible only via roadway R-2. Potential contamination from these dumps would drain into ditch D-2 and be transported to the Hackensack River.

A large mound has been deposited south of the site, adjacent to the railroad near where two elongated mounds were seen in 1940. This mound and evidence of earthmoving activity appears to be associated with roadbed construction. The mounds will be annotated but will no longer be discussed unless waste disposal activity is noted or river channel modification is observed.

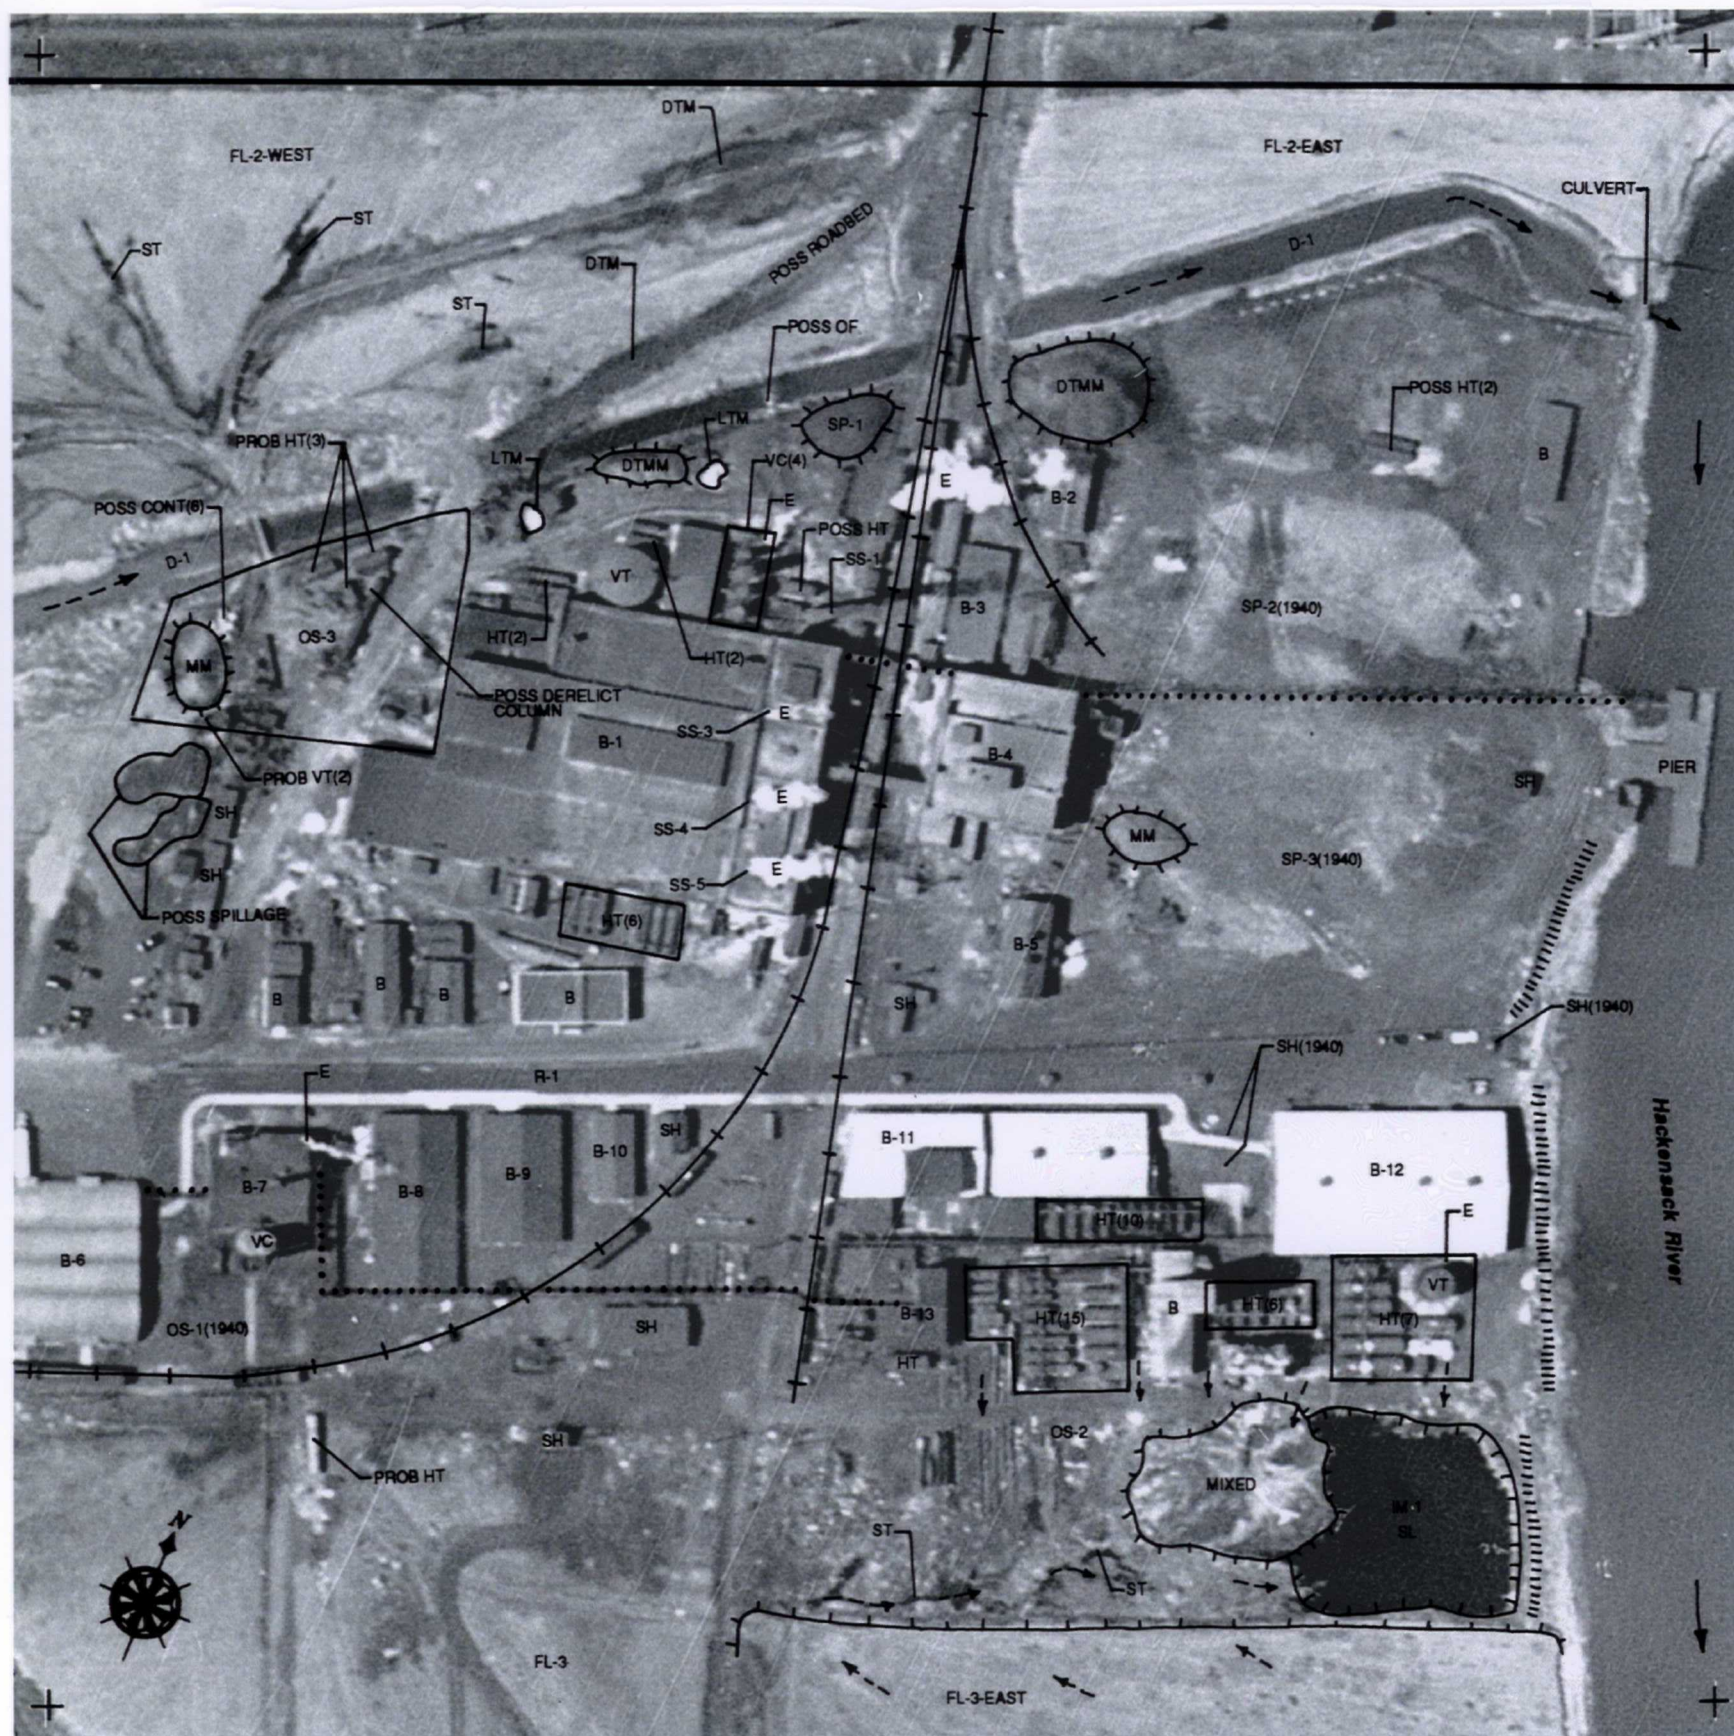
Ground stains and dark-toned material are still observed north of ditch D-1 and a possible roadbed under construction in area FL-2-West crosses ditch D-1 to the north of building B-1. Building B-1 does not appear significantly changed since 1940; however, stockpile SP-1 north of building B-1 appears to have been reduced in size. On the north side of building B-1 four vertical columns, one large vertical tank (VT), four horizontal tanks, and one possible horizontal tank are observed. There are also patches of light-toned material and dark-toned mounded material. Smokestack SS-1 is still visible and three additional smokestacks (SS-3 through SS-5) can be seen on the roof of building B-1. Emissions (E) are visible from all four of these smokestacks. Six horizontal storage tanks and support/storage sheds/buildings (not annotated) are observed on the south side of building B-1. The west side of the building is being used as an open storage area (OS-3) which lacks good housekeeping practices. Three probable derelict horizontal tanks, two probable derelict vertical tanks, one possible derelict column, a group of six probable containers (CONT), and mounded material are noted in this area. Dark-toned areas south of area OS-3 appear to be possible spillage.

The four buildings (B-2 through B-5) south of FL-2-East remain but the two stockpiles SP-2 and SP-3, observed in 1940, are absent. Two possible derelict horizontal tanks are observed in the open area east of building B-2 and an accumulation of dark-toned mounded material is visible north of building B-2. Mounded material is visible east of building B-4. Since 1940 a pipeline has been constructed between building B-4 and the river pier. The resolution of the 1947 photograph permits the identification of a culvert at the terminus of ditch D-1 where it flows into the Hackensack River.

The tank farms south of buildings B-11 and B-12 have been enlarged to contain 1 vertical and 38 horizontal tanks. No secondary containment structures are discerned around these groups of tanks; however, an impoundment (IM-1), without a discernable bottom lining, has been formed on the south side of the tank farms. Leakage or spillage from the tank farms is likely to drain into this impoundment. A dark-toned liquid (SL) is visible within the impoundment. Dark-toned ground stains and a large pile of mixed light- and dark-toned material are still visible in this area.

Ongoing filling operations are visible to the south of impoundment IM-1. Work at the expanded fill area (FL-3-East) has raised and leveled the land on the south side of open storage area OS-2.

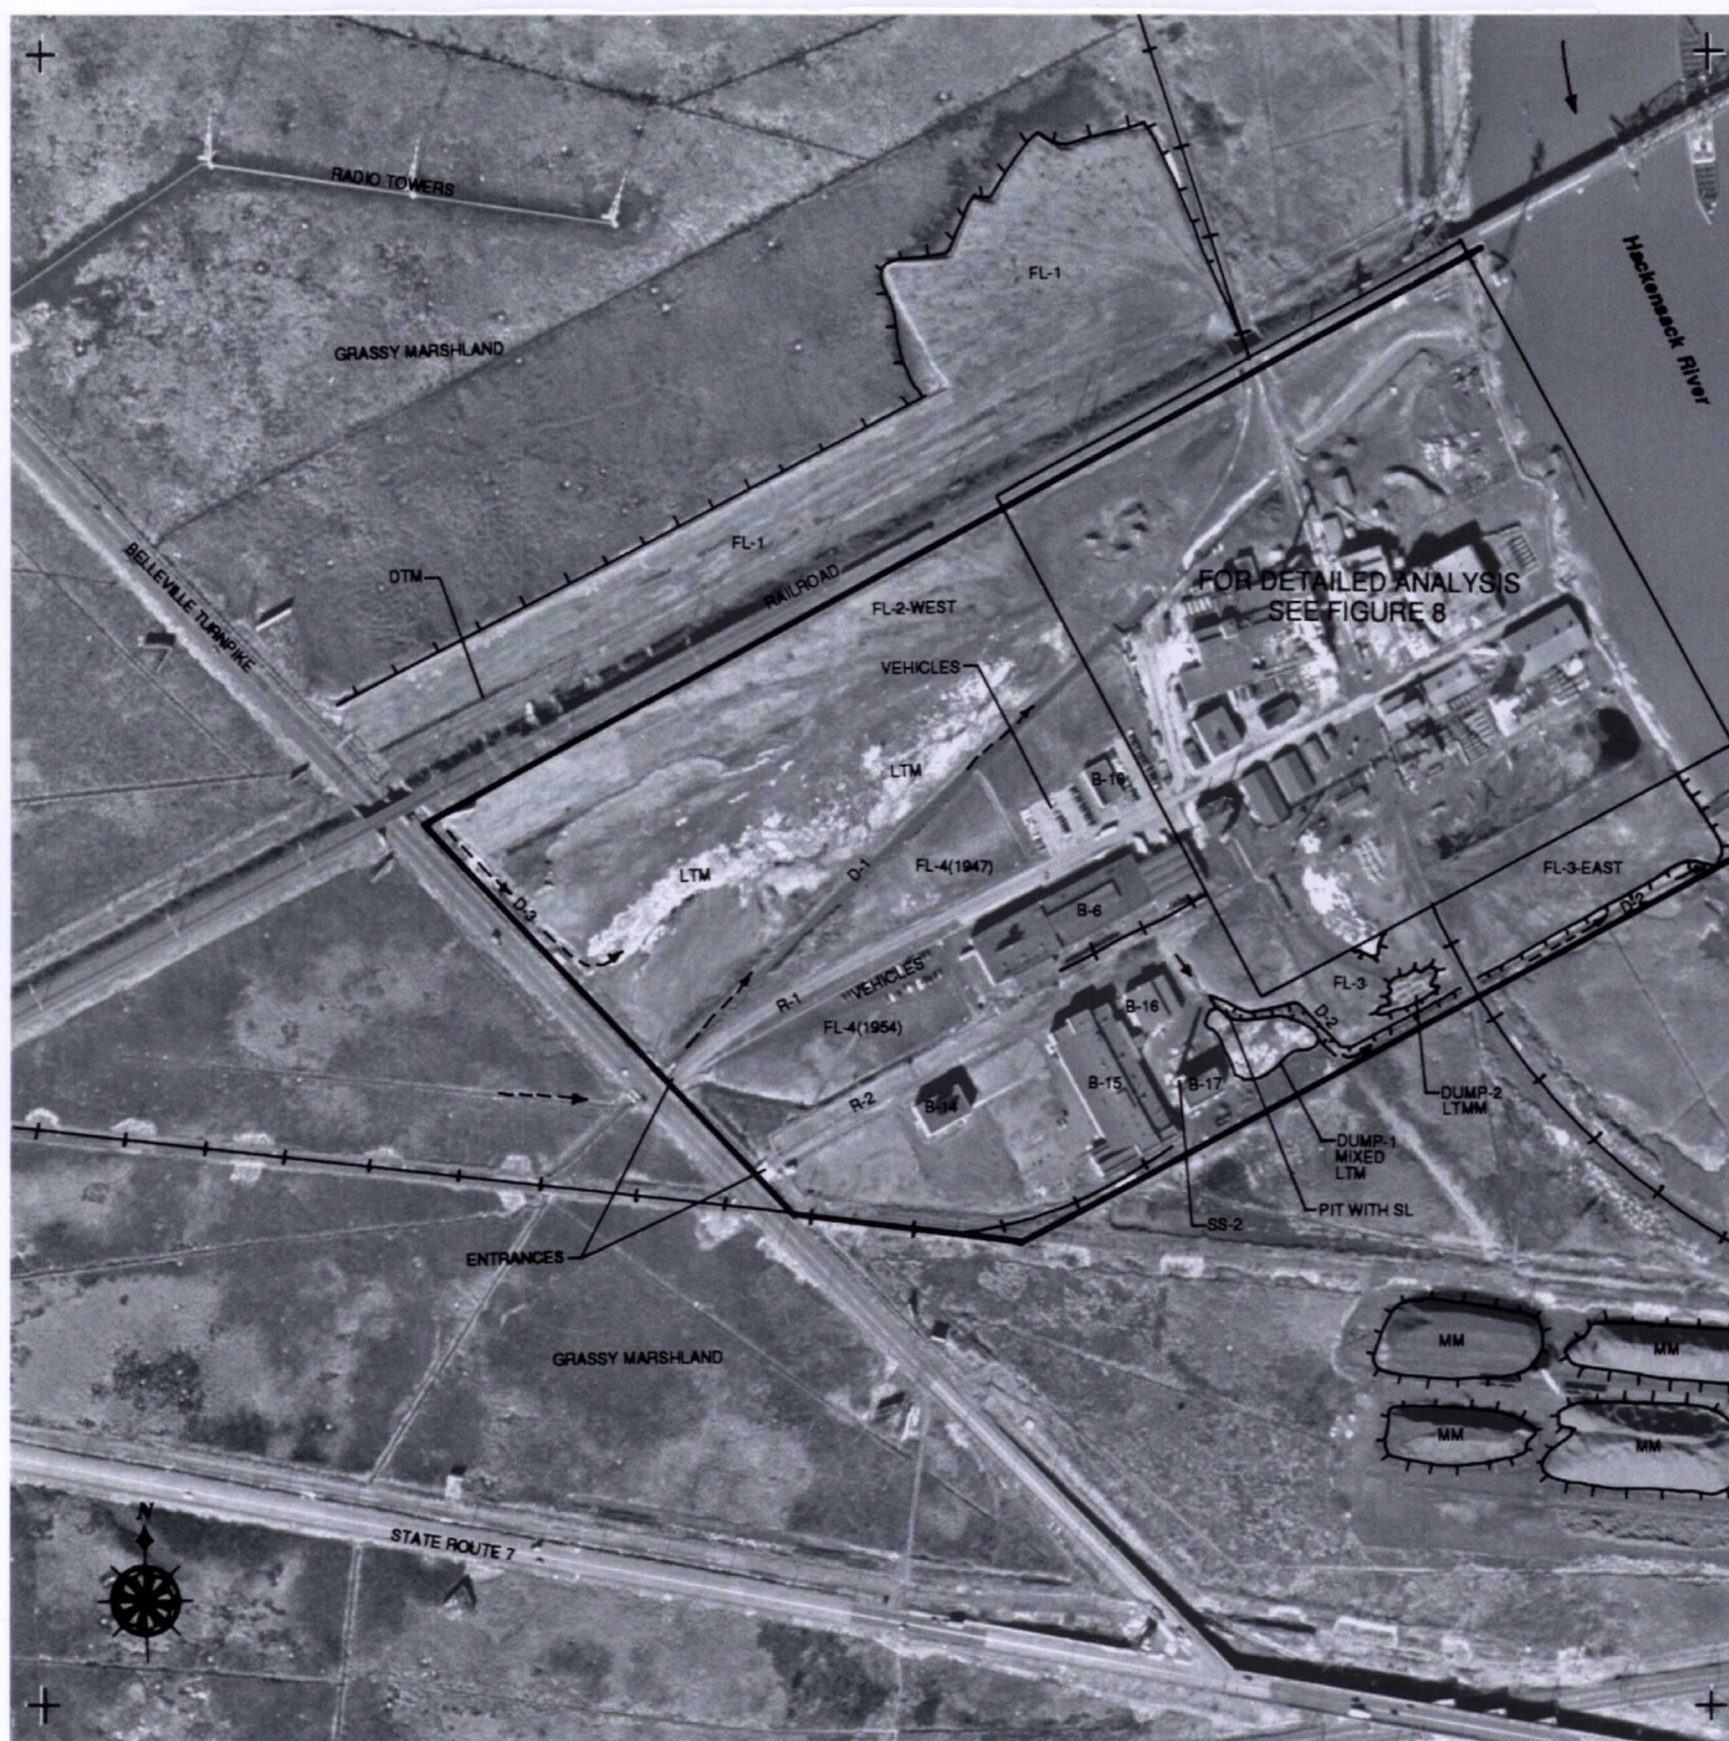
Fill areas FL-1 and FL-2-West are still visible. Numerous patches of light-toned material are noted in fill area FL-2-West but dark-toned material and ground stains are less evident compared to observations in 1947. The western edge of fill area FL-2-West appears to be the active zone of dumping and filling operations. The Hackensack River channel does not appear to have been altered by these filling operations.

Buildings B-14 through B-17 on the south side of roadway R-2 do not appear to have been modified since 1947. Neither railroad cars nor cargo trucks are observed at building B-15, as they had been in 1947. Drainage ditch D-2 receives runoff from the east side of buildings B-16 and B-17; a pit containing a dark-toned liquid is observed at the head of this ditch, northeast of building B-17. The dumping of mixed light- and dark-toned material on the east side of building B-17 continues (Dump-1). Further to the east of Dump-1 the second dump (Dump-2) contains light-toned mounded material.

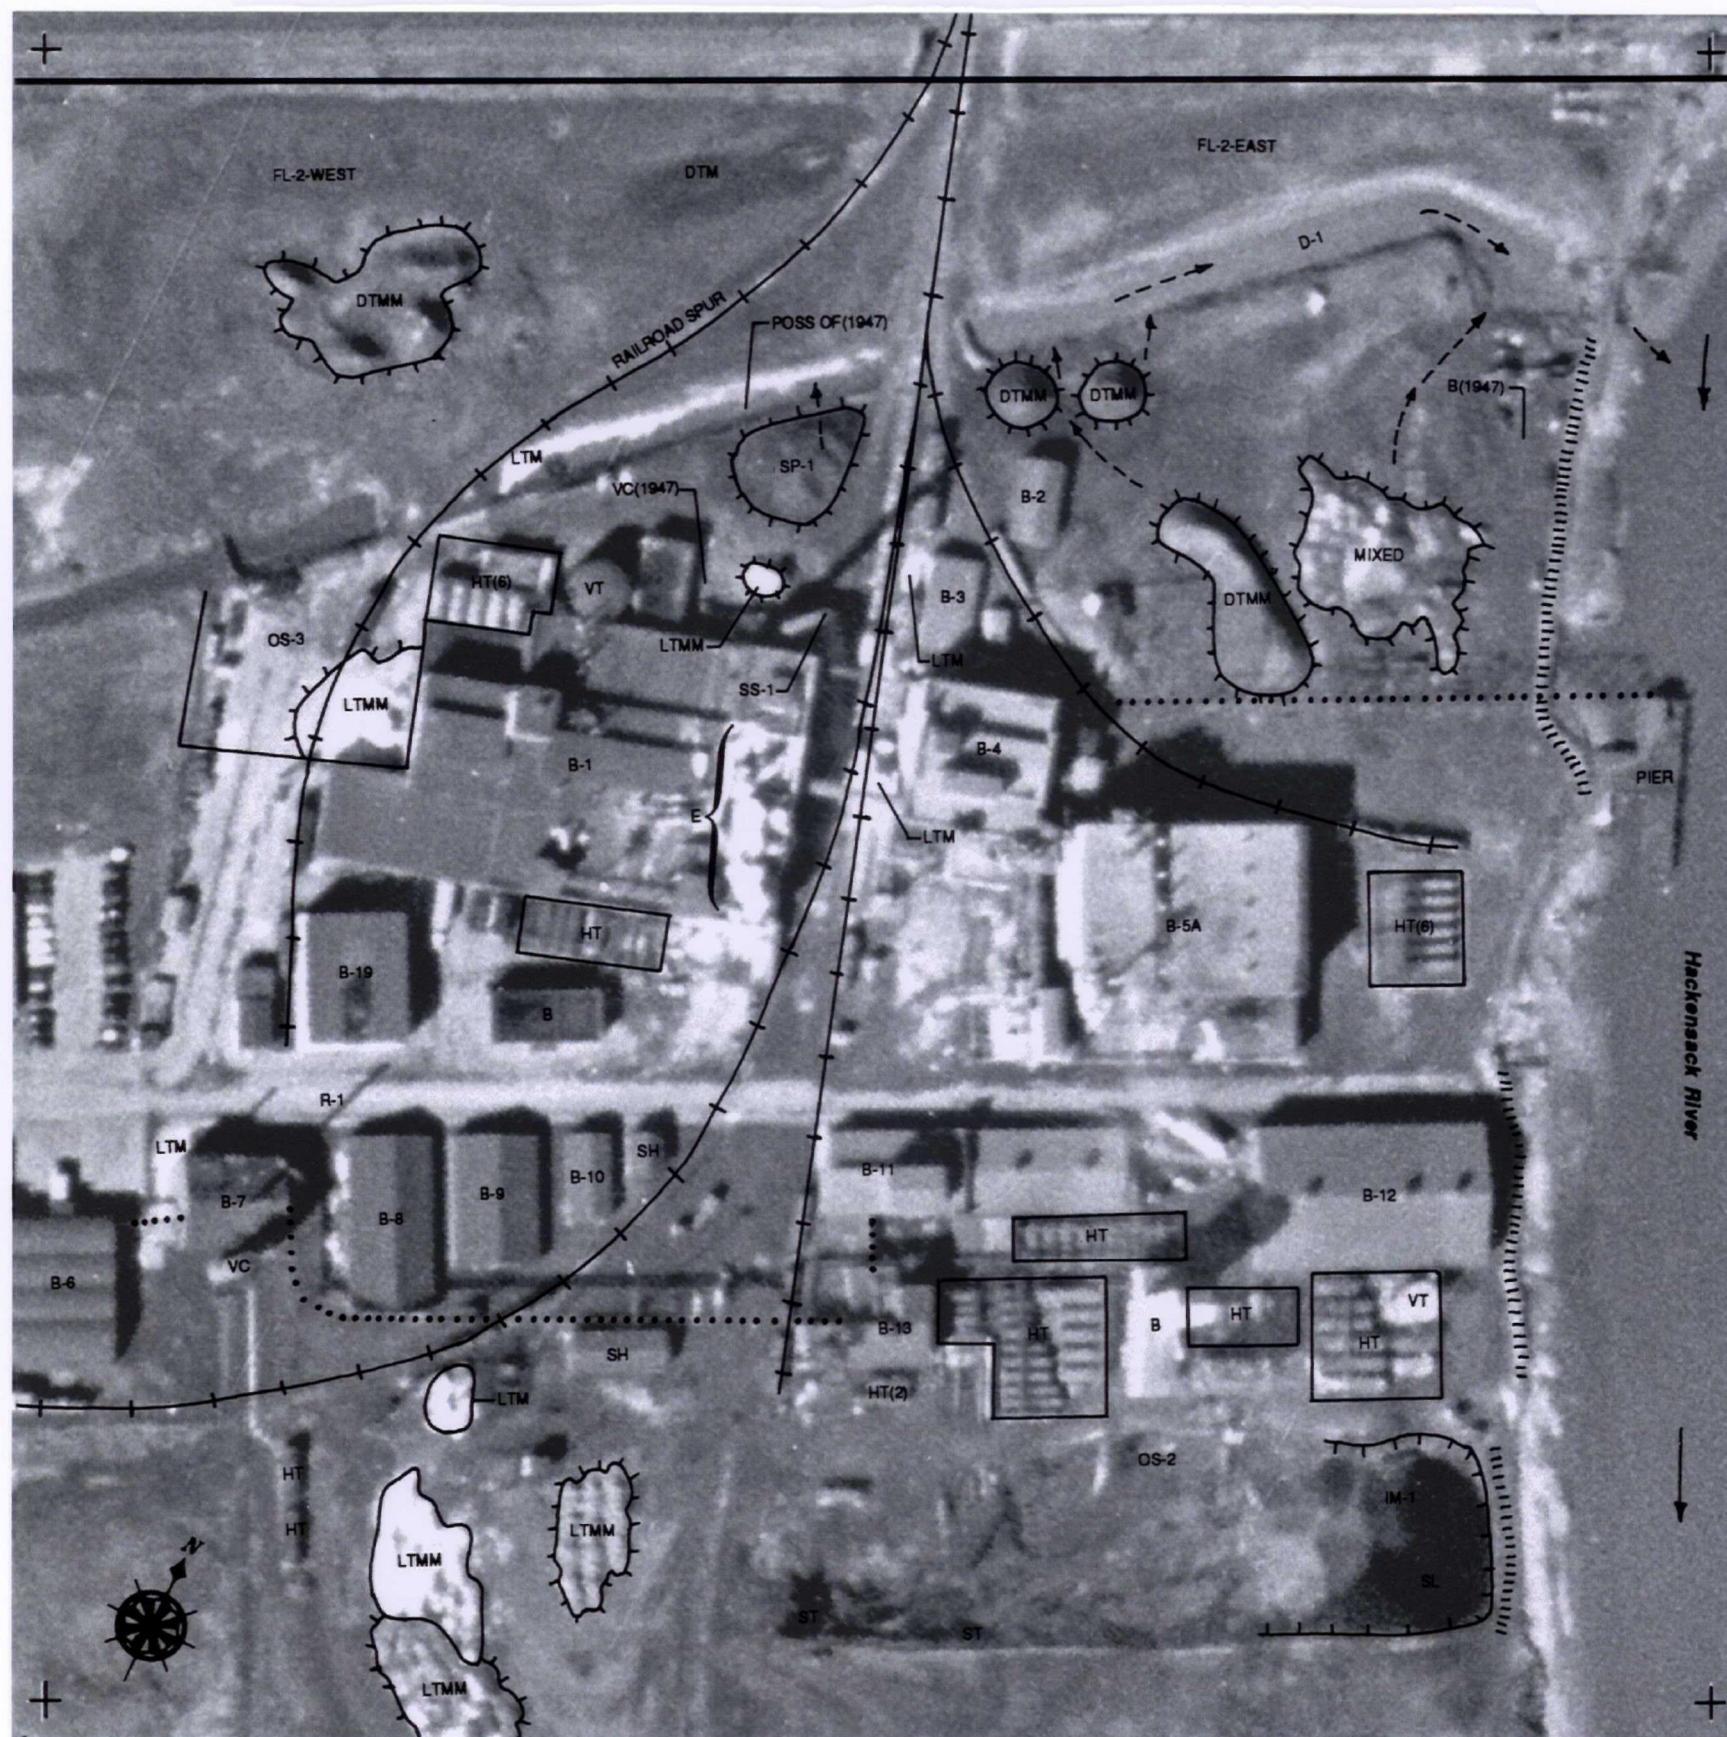
The Standard Chlorine site continues operations; a perimeter fence is still not discerned. A railroad spur has been constructed from the north across fill area FL-2-West and serves the west side of building B-1. The four vertical columns and possible horizontal tank noted in 1947 are no longer observed on the north side of building B-1. Currently light-toned mounded material is in this area. The probable derelict horizontal tanks, probable vertical tanks, derelict column, and probable containers noted in open storage area OS-3 in 1947 are absent. The dark-toned, possible ground stains seen south of OS-3 in 1947 are not evident. Patches of light-toned mounded material are observed in OS-3 adjacent to building B-1. Three of the four smokestacks on building B-1 show emissions. The poor photo resolution does not allow counting the horizontal storage tanks (not annotated) on the south side of building B-1 although they appear unchanged. The small sheds/buildings south of building B-1 have been removed and building B-19 has been constructed.

A new building (B-5A) has been constructed southeast of building B-4. Six horizontal tanks have been installed east of building B-5A and appear to have a secondary containment structure (not annotated). The elevated pipeline that runs from building B-4 to the river pier is still visible but no barges are observed. The railroad spur has been extended along the north side of building B-4 to serve building B-5A. The open area north of building B-5A contains dark-toned mounded material and deposits of mixed light- and dark-toned material. Two deposits of dark-toned mounded material are also visible north of building B-2. Surface runoff from this northeast portion of the plant is likely to enter ditch D-1 because a berm is now observed along the river bank at the east side of the chemical plant.

The tank farms to the south of buildings B-11 and B-12 do not appear to have been modified since 1947. The poor resolution precludes counting individual tanks but allows the shadow of elevated pipelines between buildings B-7, B-13, and B-11 to be discerned. The mixed light- and dark-toned material previously noted in storage area OS2 is less evident; however, impoundment IM-1 continues to contain a dark-toned liquid.

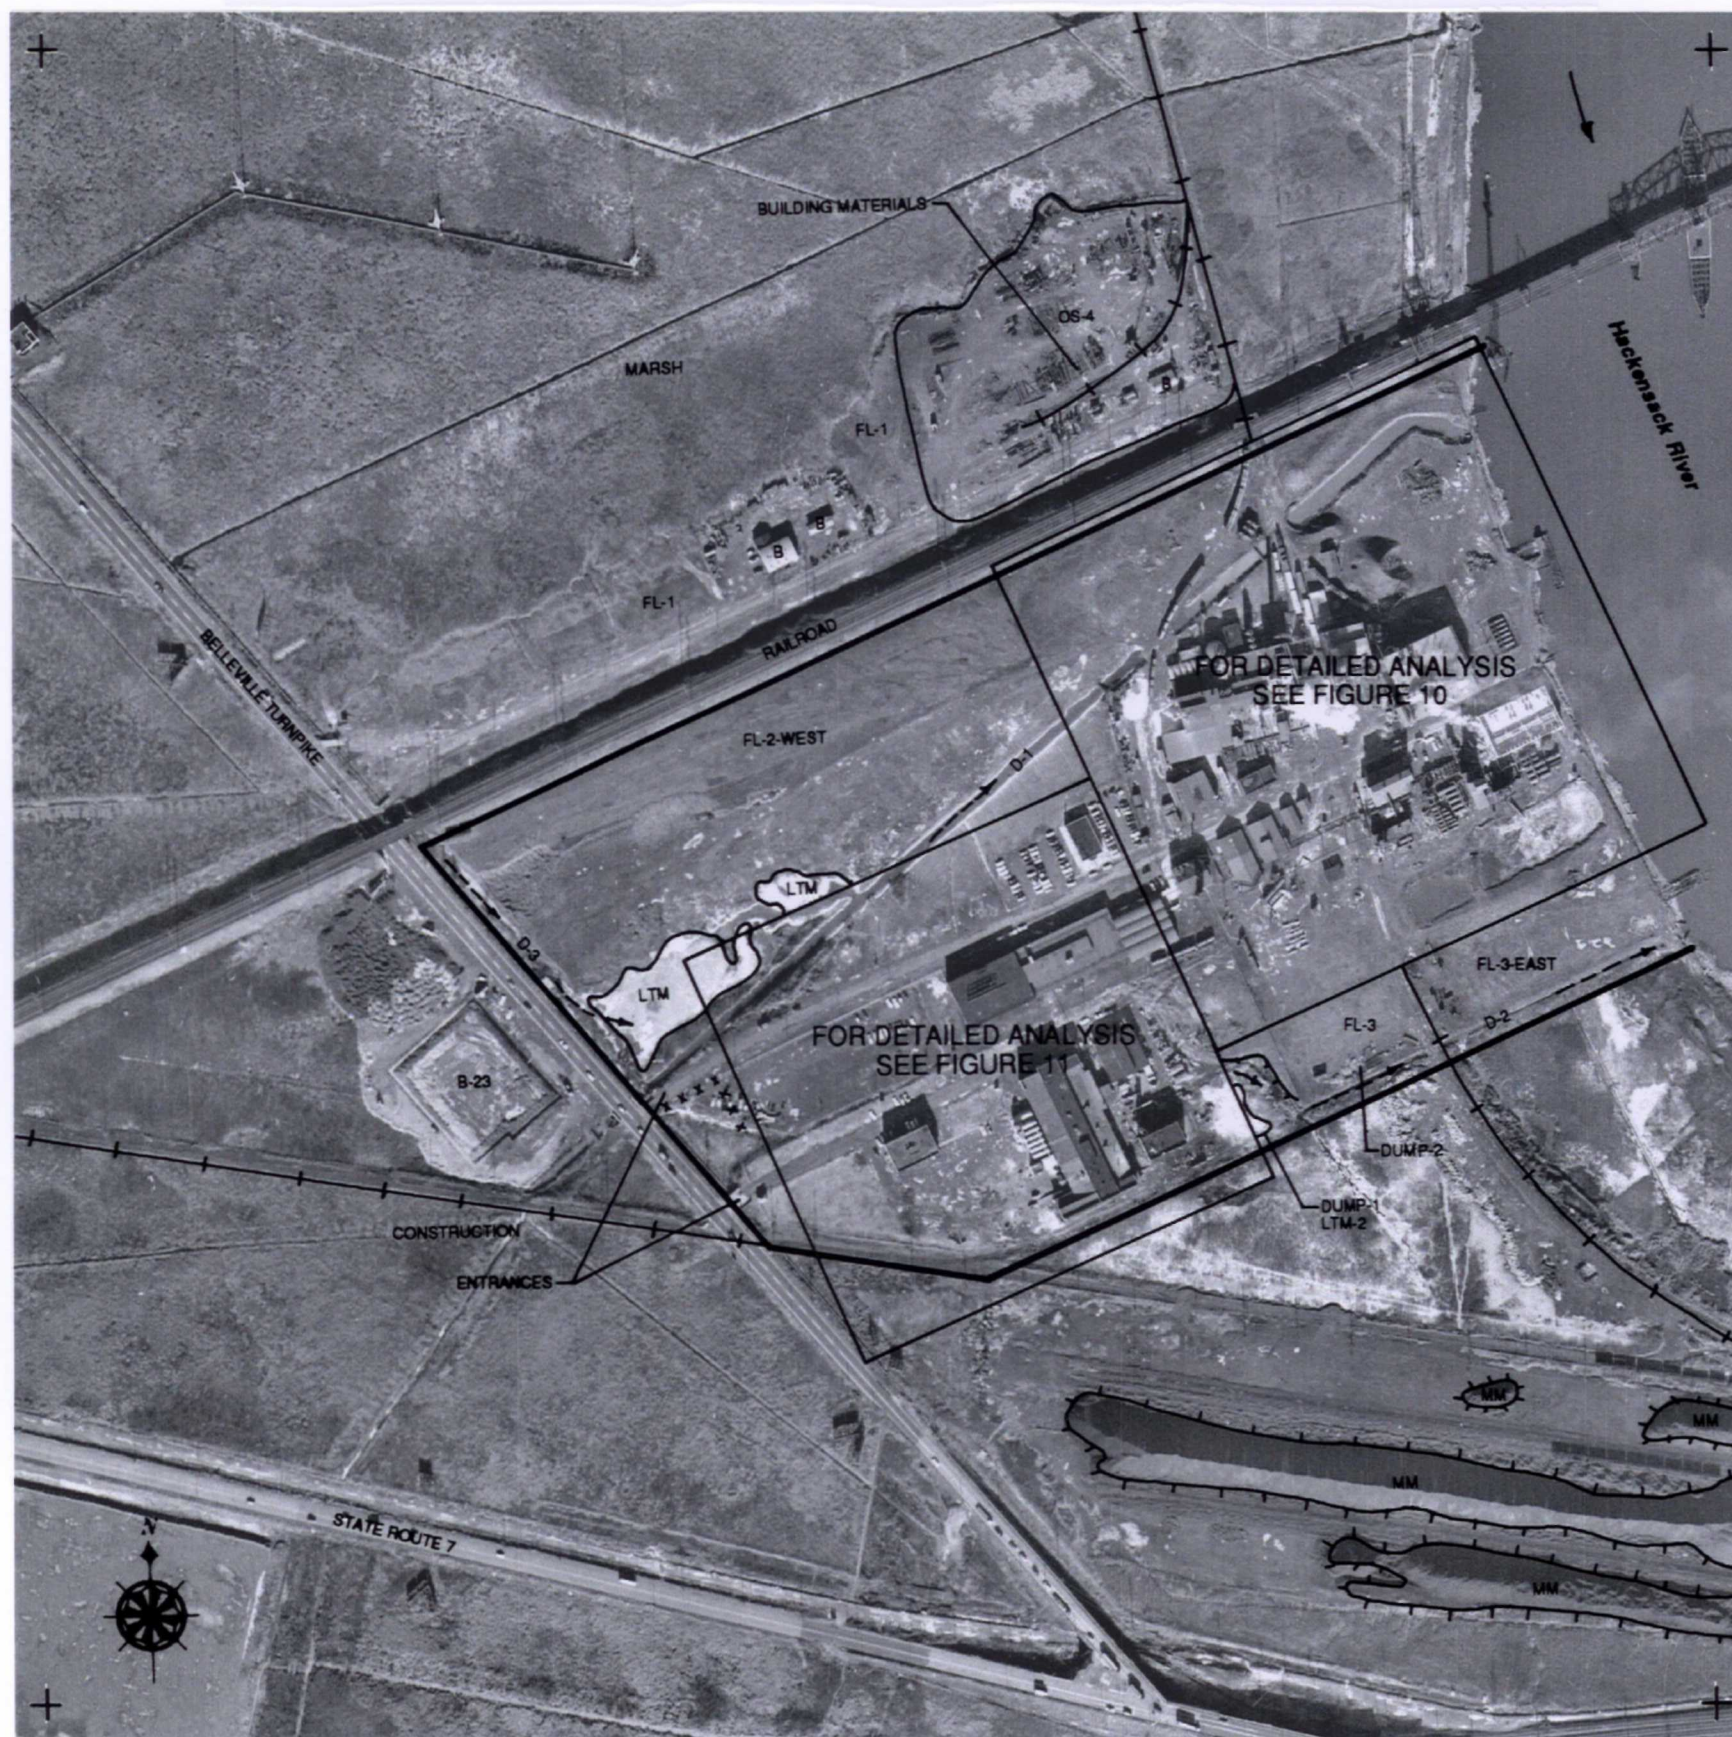
Construction activity is visible at fill area FL-1 on the north side of the railroad (north of the site). Two buildings have been erected and a large open storage area (OS-4) containing building materials has been established on portions of the former fill area. The previously noted patches of dark-toned material or dark-toned stains in this area are not apparent.

The open dump areas Dump-1 and Dump-2 situated east of building B-17 along the southern side of the plant continue to accumulate mixed light- and dark-toned material, possible debris and solid waste (not annotated). Surface runoff from this portion of the plant drains into ditch D2 and eventually reaches the river.
